<p>VEHICLE SERVICE BULLETIN</p> <p>Issued by :</p> <p>Fleet Solutions</p>	<p>VSB No: 1117E</p> <p>VERSION: 01</p> <p>DATE: 2009 04 03</p>
	<p>EQPT CODE: CPUML (3501)</p> <p>CHASSIS CODE: LX1D1</p>

SUBJECT: BATTERY ISOLATOR BY PASS FOR CHARGE LINE

MODELS: 2008 GROUP 35 ON F-550 CHASSIS (3501)

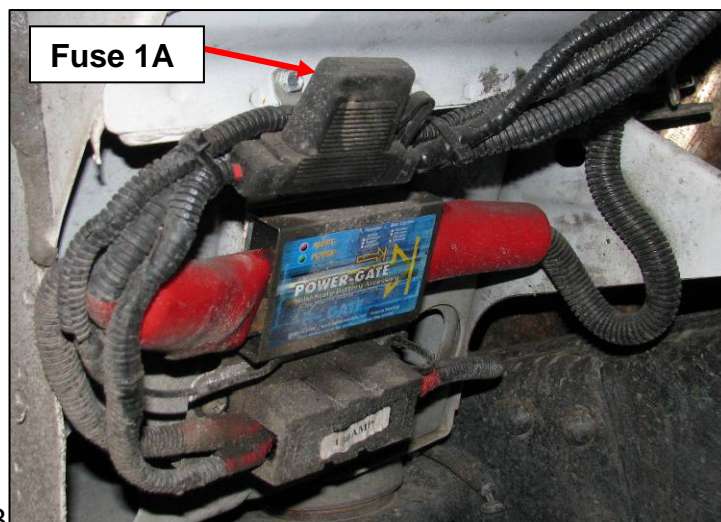
Problems have occurred with the 2008 group 35 12 Volts charge system. In order to avoid any possible damage to the vehicles, the battery isolator needs to be by-passed until the root cause of the problem is found.

1. Disconnect all 3 batteries prior to perform any work. Two batteries are located under the hood and one battery located under the generator on driver side front compartment.
2. Remove the inside fender protector at the front passenger side wheel well to gain access to the isolator.
3. Test the continuity on the 1 amp ground fuse of the isolator. Report result in completed work form.
4. Check for loose nuts/bolts on all connections. Report result in completed work form.
5. To by-pass the isolator, connect all 3 wires connected to the isolator to the same blade.

6. Reconnect all 3 batteries. Test charge line for proper charging when engine is running. Verify that all accessories are properly functioning.
